**Report of Findings**

**Parker (Catina) v City of Gulfport, et al.**

Fusion Engineering was asked to analyze and reconstruct an accident that occurred on February 1, 2020, where the driver of a GMC pickup truck was shot and killed by a police officer in Gulfport, Mississippi.

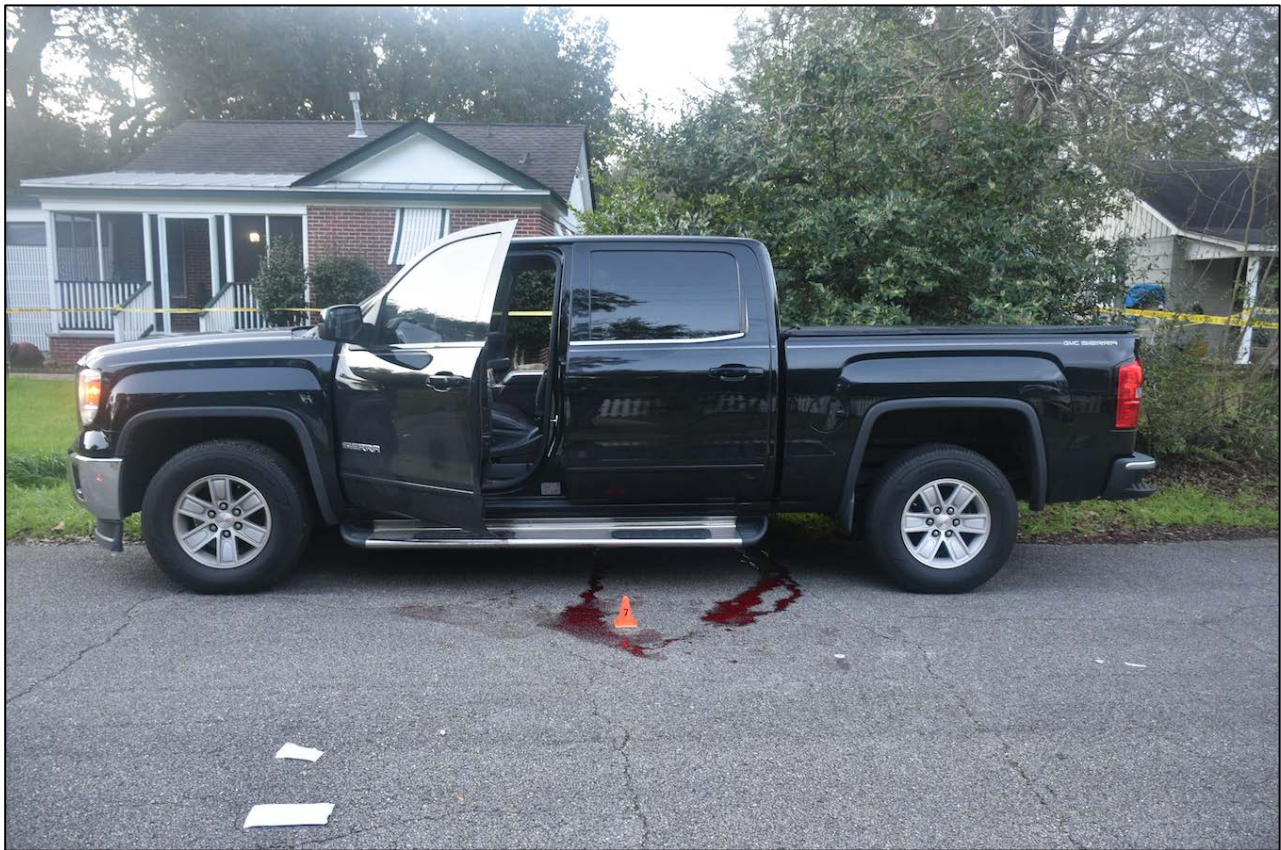
Mr. Parker was driving a 2014 GMC Sierra 1500 SLE Crew Cab 2WD bearing the VIN 3GTP1UEC7EG178416. The truck was RWD, had a 5.3L V8 engine, a wheelbase of 143.5 inches, a turning radius of 23.6 feet and a curb weight of 4,942 lbs. The truck was equipped with Pathfinder HT 265/70R17 tires. A post-accident photograph of the truck at its point of rest (POR) is shown in Figure 1.

*Figure 1: Post-accident photograph (BLT\_0202) taken on February 1, 2020, at 7:51:22 a.m.*

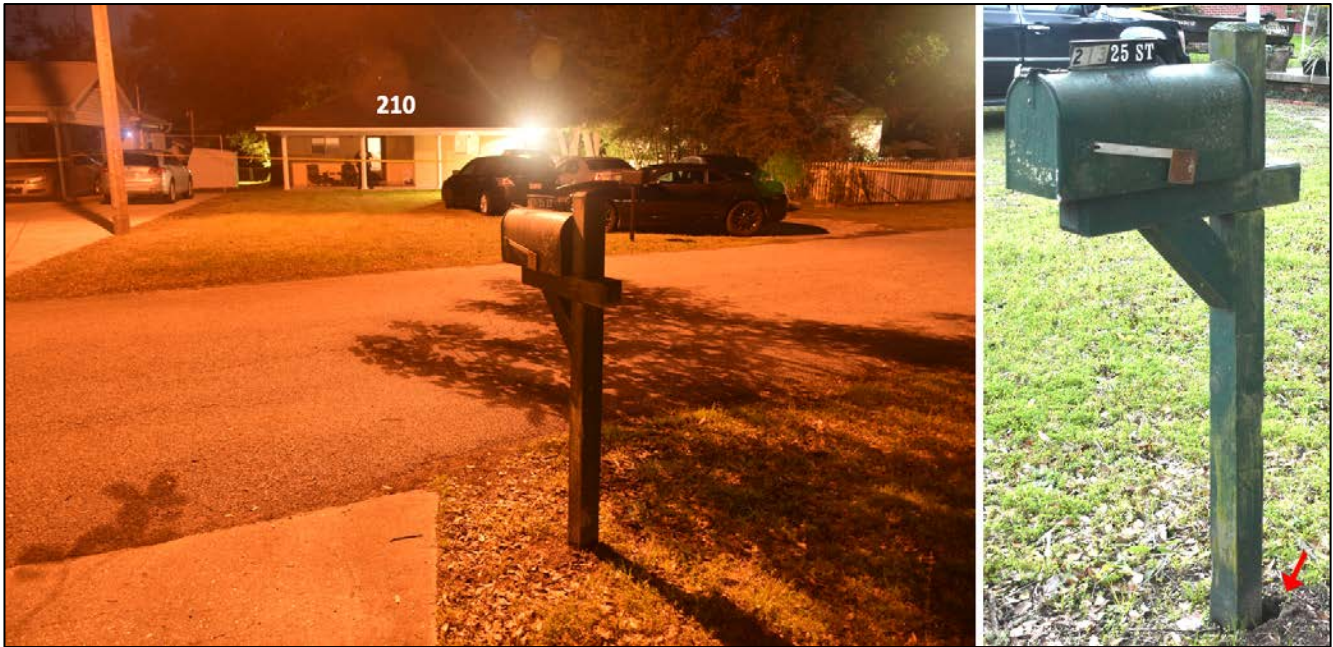
Figure 3: Annotated post-accident photograph (BLT\_0129) taken on February 1, 2020, at 7:01:58 a.m. (left) and annotated post-accident photograph (BLT\_0242) taken on February 1, 2020, at 7:59:58 a.m. (right)

Of note, the green mailbox at 213 25<sup>th</sup> Street had been replaced with a white mailbox at the same approximate location. The new mailbox is shown in Figure 13 and Figure 14 and a comparison to Figure 3 demonstrates that the mailbox location has not substantially changed. The white mailbox at 208 25<sup>th</sup> Street remained the same.

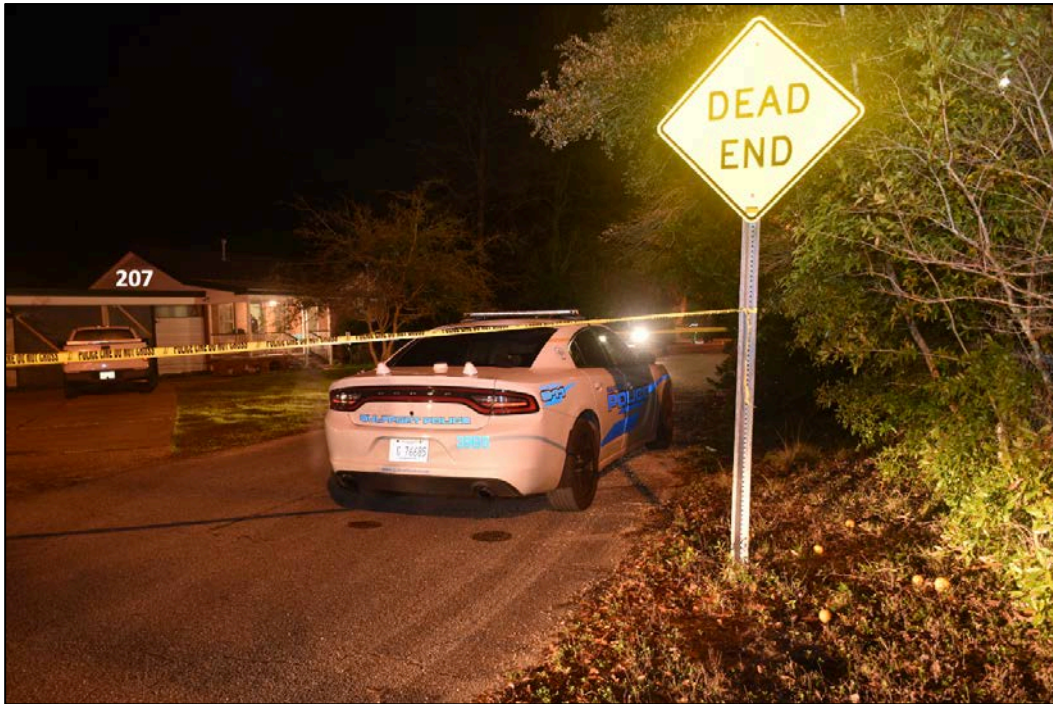
As shown in Figure 4, Officer Cuevas parked his vehicle on the north side of 25<sup>th</sup> Street across the street from the driveway of 207 25<sup>th</sup> Street. The red arrow in Figure 5 identifies the 208 25<sup>th</sup> Street mailbox that Officer Cuevas was walking towards when he noticed the truck backing up from the yard of 210 25<sup>th</sup> Street. Figure 5 also shows the parked location of Officer Cuevas' police vehicle and the headlights of the subject truck at its point of rest. As shown in Figure 6, the truck's post-accident point of rest is across the street from the 208 25<sup>th</sup> Street mailbox and just west of the western face of the 207 25<sup>th</sup> Street house.

Figure 4: Annotated post-accident photograph (BLT\_0035) taken on February 1, 2020, at 6:22:27 a.m.

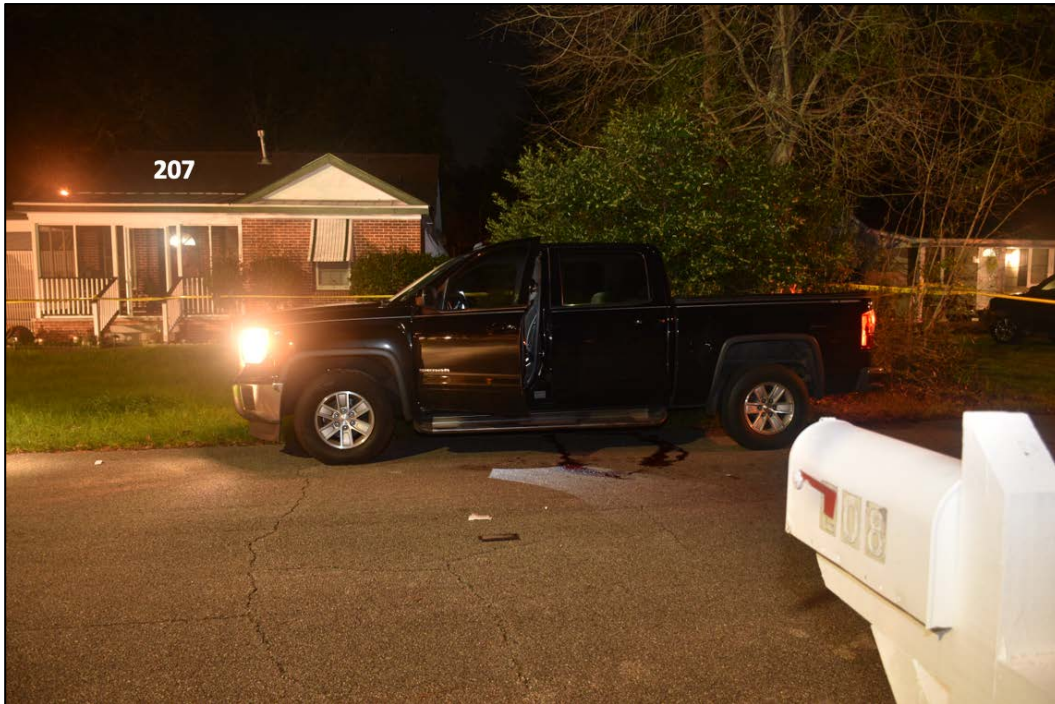
*Figure 6: Annotated post-accident photograph (BLT\_0068) taken on February 1, 2020, at 6:35:24 a.m.*

The post-accident photographs and video taken by Investigator Brandon Teates documented the truck in drive, with the parking brake not applied and with the engine running at approximately 500 RPMs at its point of rest. The police report indicates that the vehicle did not continue to move forward because the doors were open but that is incorrect. This will be discussed later in the report. As shown in Figure 7, the headlights were illuminated, and the front wheels were straight (not turned). The red arrow in Figure 7 points to a line of matted down grass that indicates the truck was traveling straight prior to coming to a stop. As shown in Figure 8, the truck came to rest approximately parallel to the road with its left side tires on the asphalt roadway and its right side tires in the grass that is just south of the roadway. A review of the post-accident police photographs showed that there were no obstructions in front of any of the truck's wheels that would significantly retard its forward motion.

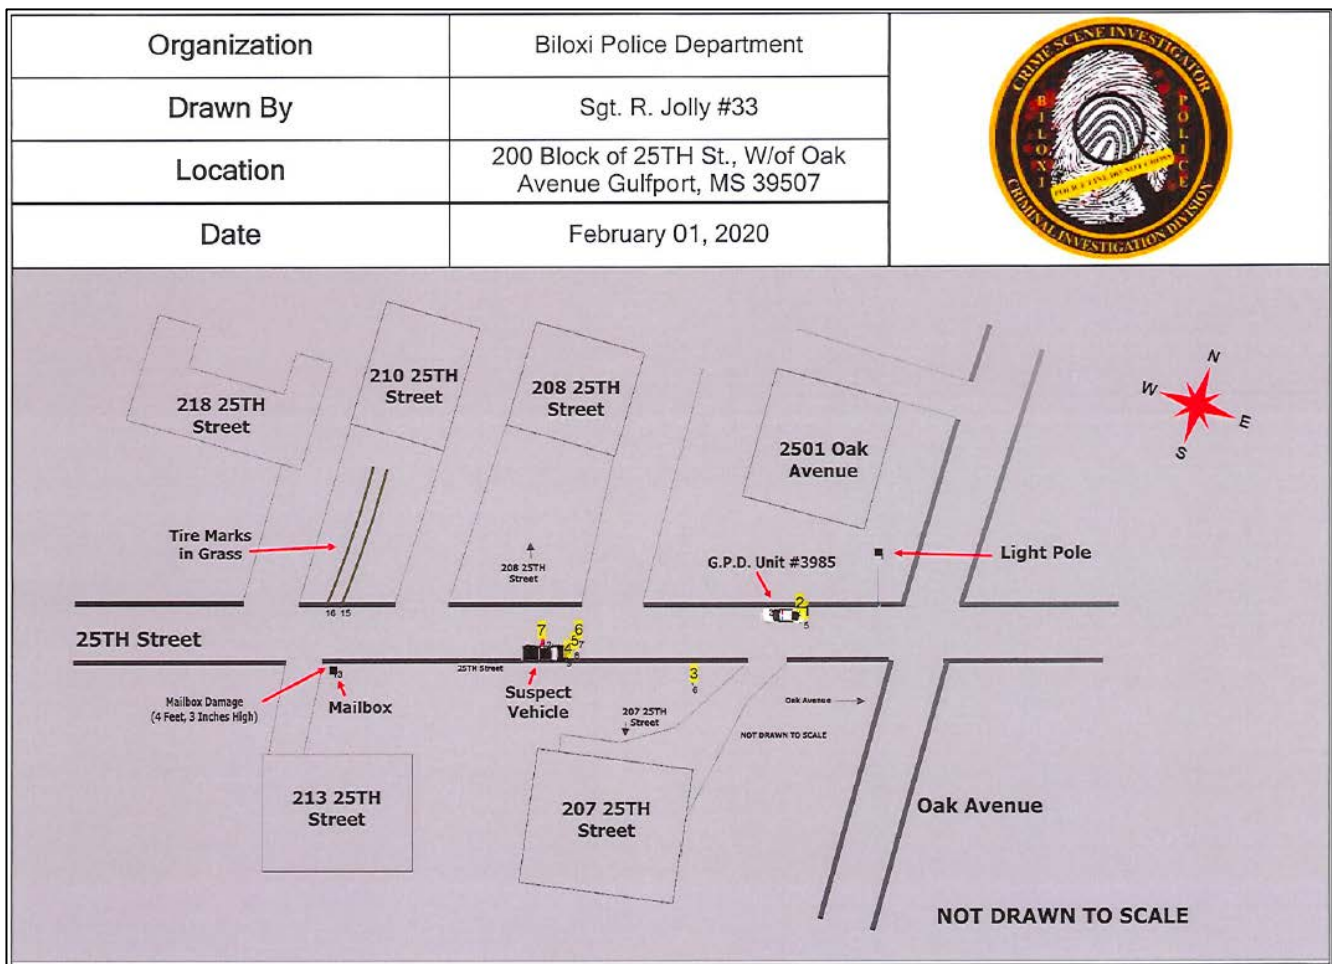
Investigator Teates testified that Sergeant Robert Jolly took the scene measurements. These measurements included the location of the tires of the subject truck and police vehicle, the shell casings, the struck mailbox at 213 25<sup>th</sup> Street, and the location of a passenger side and driver side tire marks in the grass of 210 25<sup>th</sup> street. He testified that there was dew in the grass that allowed him to see these tire marks. The BPD accident scene drawing is shown in Figure 9. Investigator Teates' initial scene analysis includes, *"Just west of the trucks location was a mailbox that was hit by the truck in the yard of 213 25<sup>th</sup> St. Damage occurred to the truck on the back passenger side when the collision occurred. The ground around the mailbox was disturbed indicating the post was pushed backwards. Tire impressions were seen in the grass of 210 25<sup>th</sup> St. that led to the mailbox."*<sup>3</sup>

Figure 9: Biloxi Police Department Accident Scene Drawing

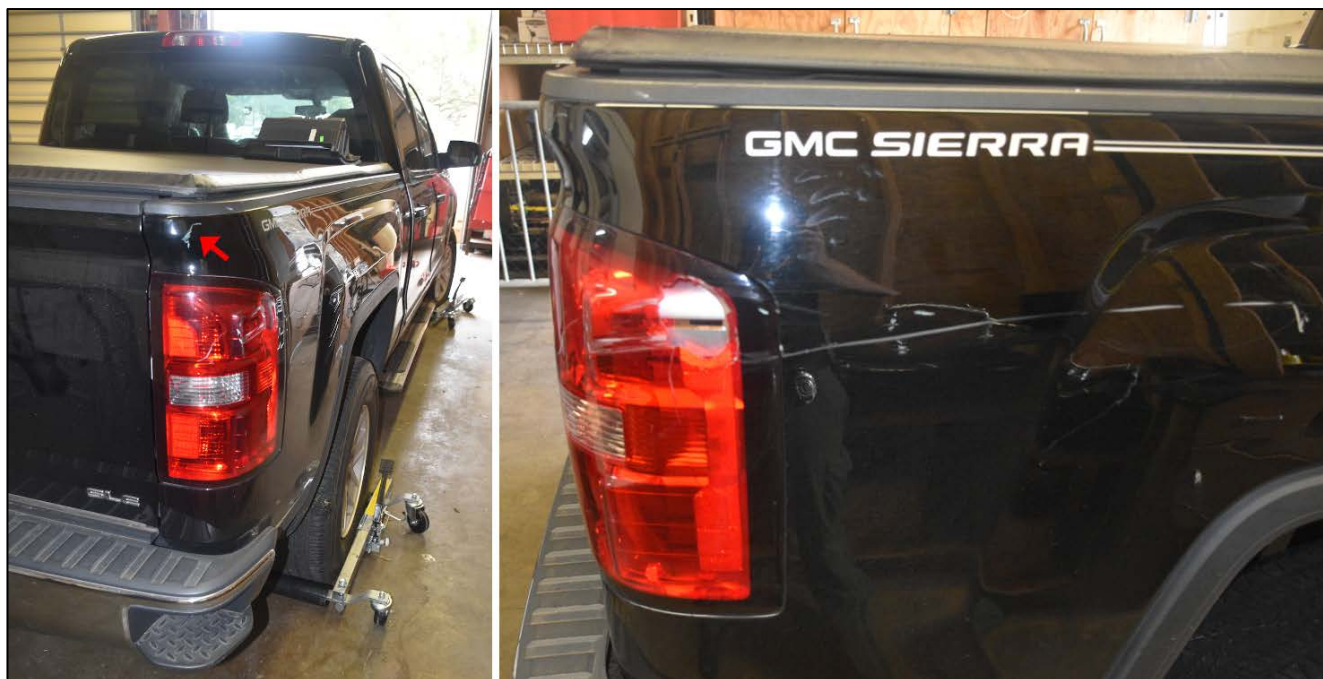
*pole sat appeared to be freshly disturbed. I then went back to the suspect vehicle and I observed green paint marks on the top of the passenger side rear taillight consistent with the slight damage on the mailbox".* His narrative further states that the height of the damage on the taillight was almost identical to the height of the damage on the mailbox. The red arrow on the left side of Figure 10 identifies green paint above the taillight of the truck that was more likely than not transferred from the mailbox. In addition, the right side of Figure 10 shows damage to the taillight cover and a scrape along the passenger side of the truck at the approximate height of the mailbox.

Figure 10: Annotated post-accident photograph (CSU\_Garage (106)) taken on February 4, 2020, at 11:14:36 a.m. (left) and post-accident photograph (CSU\_Garage (102)) taken on February 1, 2020, at 11:14:10 a.m. (right)

As discussed above, the red arrow on the left side of Figure 10 identifies green paint above the right rear taillight of the truck that was more likely than not transferred from the mailbox. In addition, the right side of Figure 10 shows damage to the taillight cover and a scrape along the passenger side of the truck at the approximate height of the mailbox. It is unknown if all or some of this additional damage was caused as Mr. Parker backed out just prior to the shooting. It is likely that the truck backed up an additional few feet beyond what is shown in Figure 22, but that possibility does not affect my analysis.

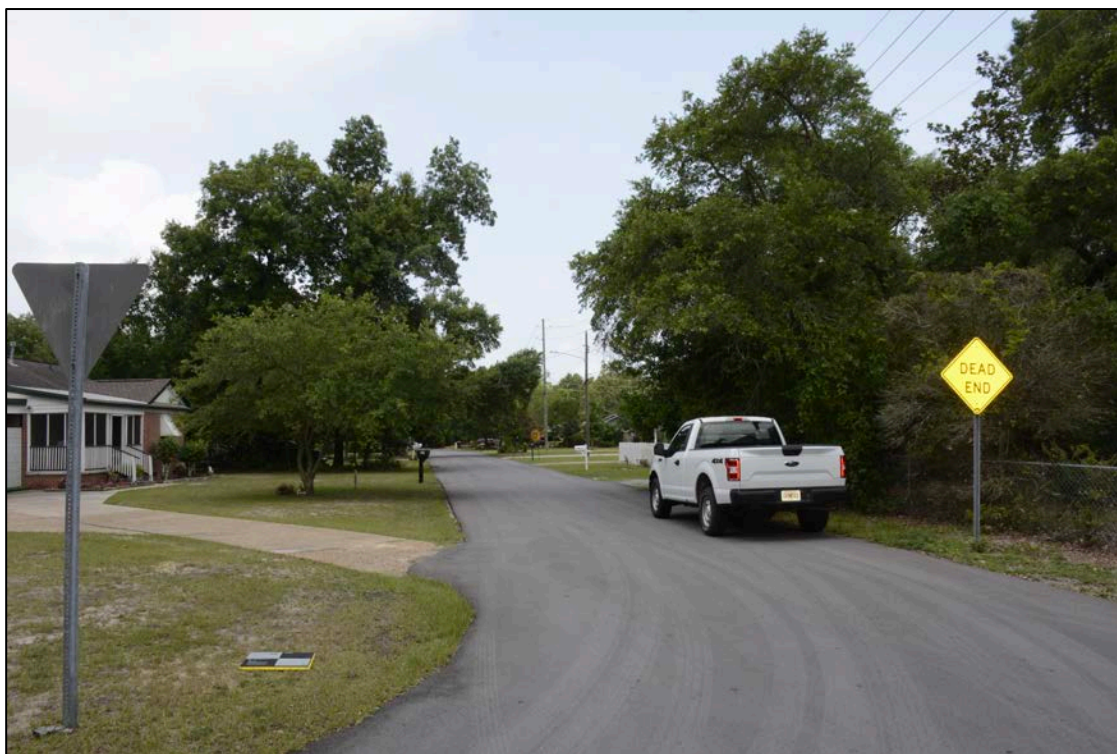
On June 15, 2023, I conducted a site inspection of 25<sup>th</sup> Street in Gulfport, Mississippi. The road had been resurfaced since the date of the accident, but the new asphalt covered the same approximate footprint (length and width) as the asphalt did on the day of the accident. In addition, there were numerous items, such as the houses and driveways, that did not change. I parked my rental truck on the north side of 25<sup>th</sup> Street (Figure 12), just west of the Dead End sign and near the location that Officer Cuevas parked his vehicle (Figure 4).

*Figure 12: Photograph from Fusion Engineering's June 15, 2023, Site Inspection*

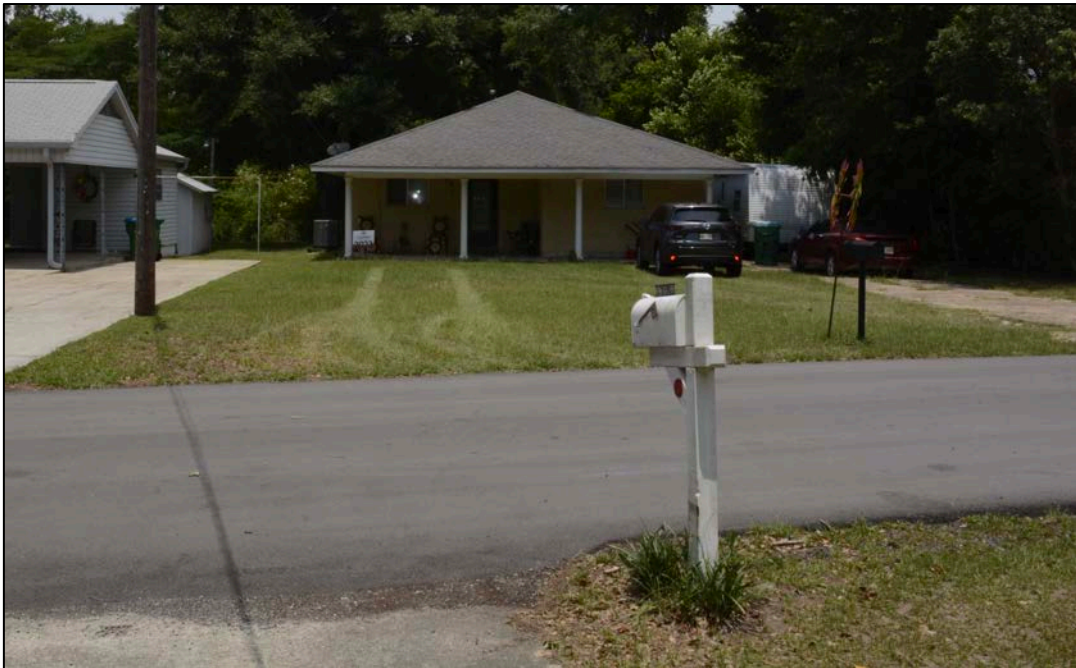
Figure 13: Photograph of the new mailbox at 213 25<sup>th</sup> Street from Fusion Engineering's June 15, 2023, Site Inspection

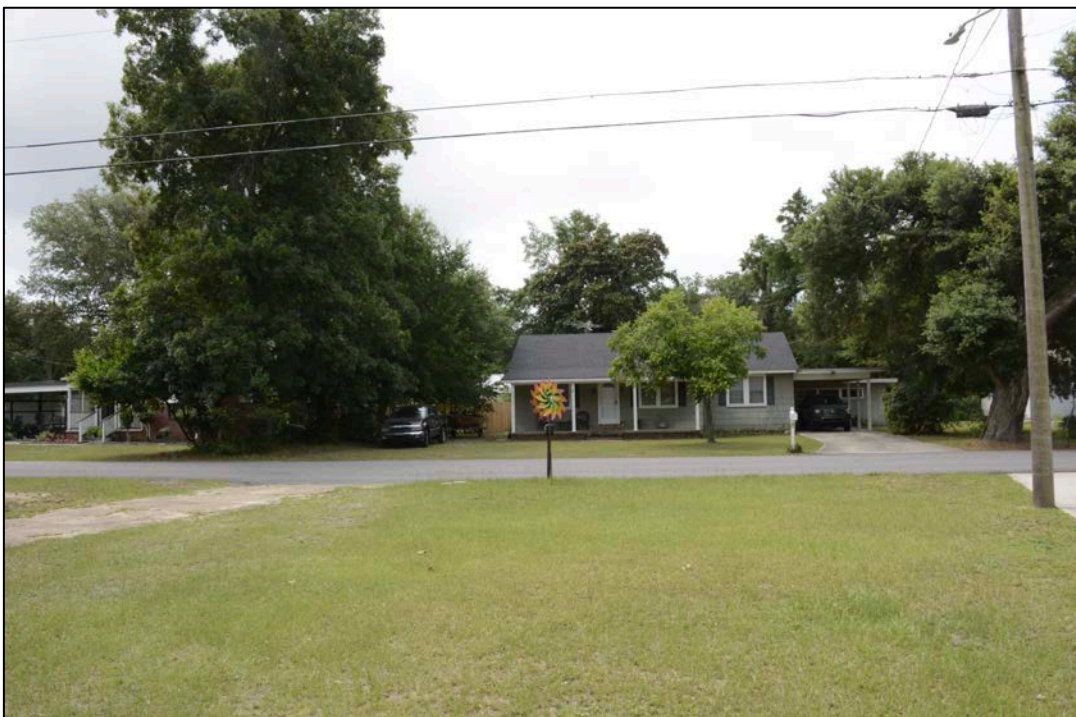
Figure 14: Photograph looking south from the yard at 210 25<sup>th</sup> Street from Fusion Engineering's June 15, 2023, Site Inspection

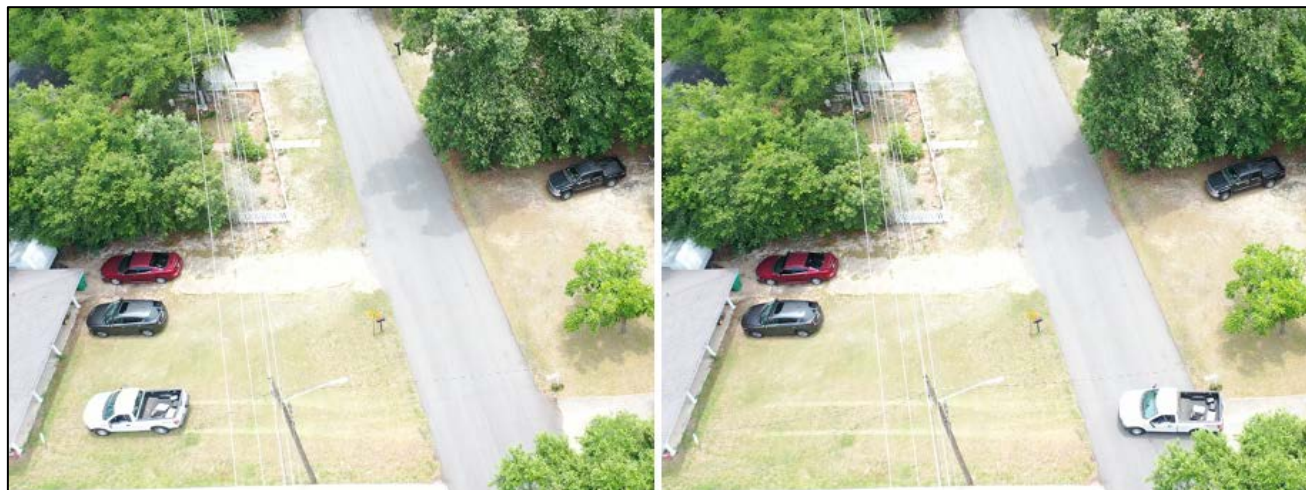
I drove a 2019 Ford F-150 truck bearing the VIN 1FTMF1EB7KFC49332 to the inspection. This truck had a 122-inch wheelbase, a 20.4 foot turning radius and a curb weight of 4,343 lbs. The truck was four wheel drive, but I left it in 2H (rear wheel drive), to better match the drivetrain of the subject truck. During the inspection I drove the approximate route taken by Mr. Leonard just prior to the shooting to demonstrate the steering wheel inputs required to arrive at the point of rest from his starting position near the mailbox at 213 25<sup>th</sup> Street. I started in the yard of 210 25th Street (left side of Figure 19) and backed up until the right rear corner of the truck was just past the mailbox at 213 25th Street (right side of Figure 19). I then drove forward and turned the steering wheel to the right to head east on 25th Street. I continued to input the right-hand turn until the truck was no longer parallel to the street and was heading southeast towards the south side of the street (left side of Figure 20). In order to end up with my right side tires in the grass and the vehicle approximately parallel to the street, I had to turn the steering wheel to the left and then allow it to come back to center before coming to a stop at the approximate post-accident point of rest (right side of Figure 20). In order to come to a stop at the point of rest, I had to apply my service brake. After I brought the vehicle to a stop at the point of rest, I released the service brake, and the vehicle began to slowly roll forward. On the day of my inspection the grass and ground were dry near the point of rest.

Figure 19: Run 5 from Fusion Engineering's June 15, 2023, Site Inspection

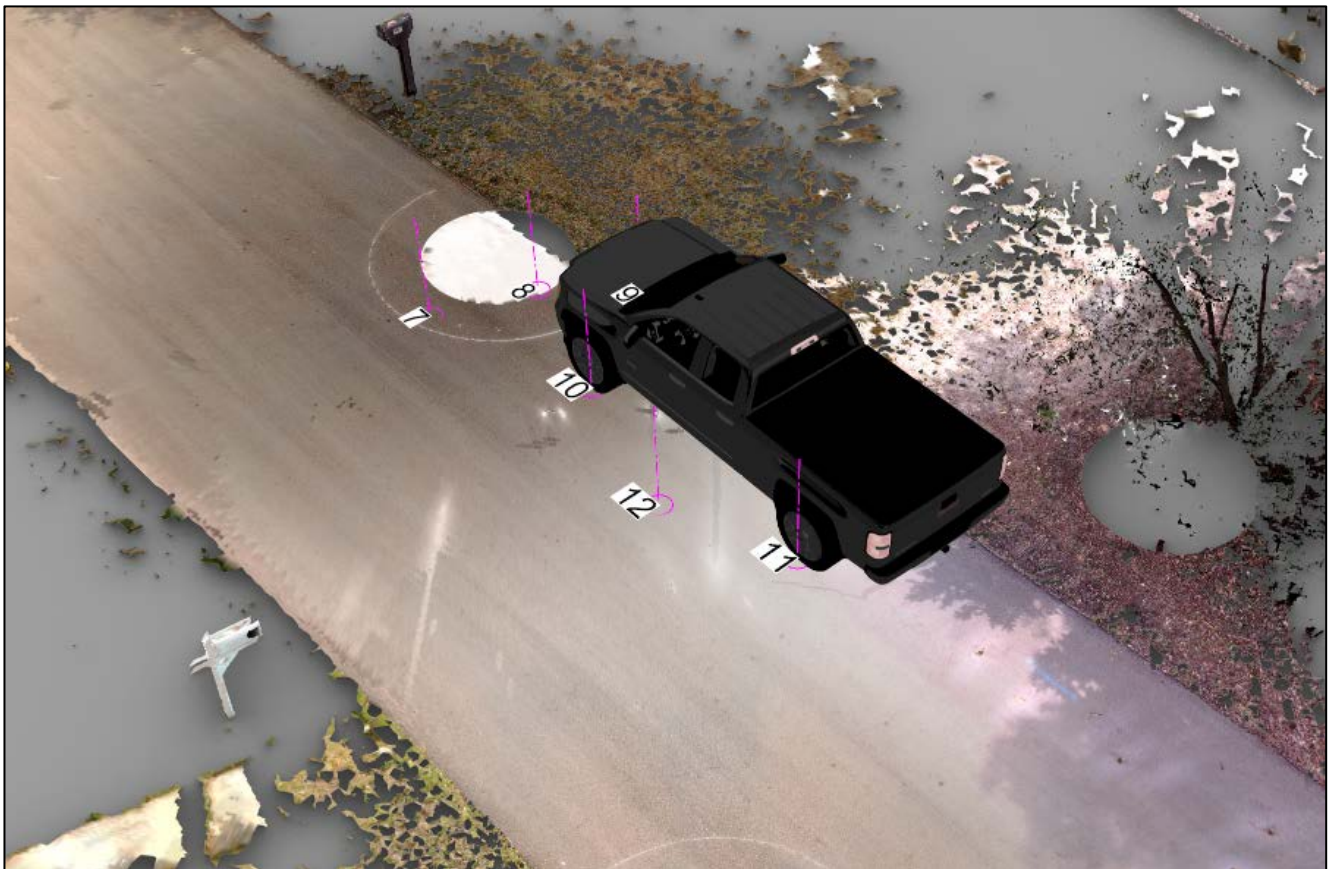
To better analyze the accident, the measurements taken by the police were input into the 3D site geometry that was captured during the Fusion Engineering site inspection. In addition, a digital model of a 2014 GMC Sierra 1500 Crew Cab was input as well. The vehicle was oriented at its point of rest based on the police measurements (D/S front tire (10) and D/S rear tire (11)) and post-accident scene photos. Figure 21 shows the truck at its point of rest with the police measurements overlaid on the 3D site geometry that was captured with the laser scanner.

*Figure 21: Digital model of an exemplar truck at its point of rest*

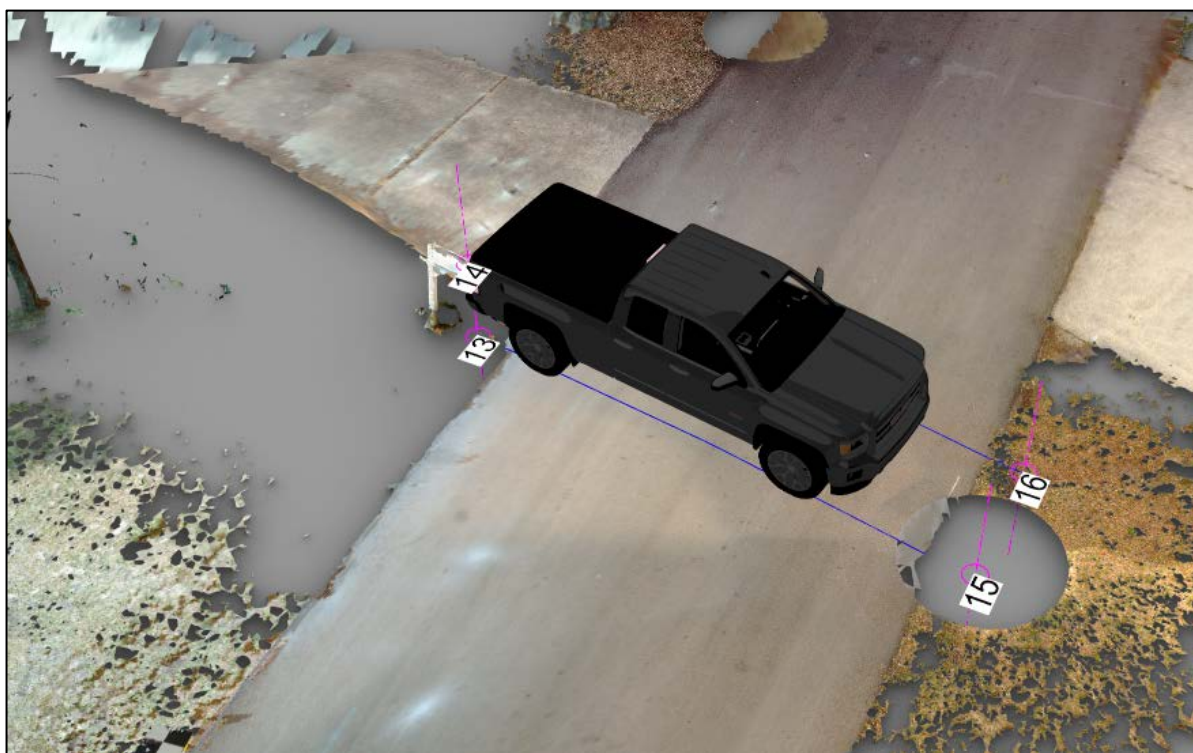
Figure 22: Digital model of an exemplar truck at its initial contact with the 213 25<sup>th</sup> Street mailbox
